## TEST REPORT

Ind. Ser. No. : 14-04-NEF-038  
Applicant : Qualtek Electronics Corporation  
Address : 7610 Jenther Drive Mentor, Ohio 44060 U.S.A.  
Products : Axial fans  
Model : FDA2-25489 、 FDA2-22580 、 FDA2-28080 series 、 FDD1-17251 series  
Quantity : 8 set  
Date of Receipt :  
Date of Testing : Reference : ETC's Report NO.14-04-NEF-001  
Test specification : IEC60529 Edition 2.1 2001-02  
Inspection Site : Electronics Testing Center, Taiwan – Southern Taiwan Industry Service Department  
(TAF Certification No:1161)  
Ambient Environment : IP5X Temp.  $23 \pm 1^{\circ}\text{C}$  , R.H.  $52 \pm 2\%$   
IPX6 Temp.  $24 \pm 1^{\circ}\text{C}$  , R.H.  $59 \pm 2\%$   
Testing Item : IP56M  
Test condition : See the following sheets  
Test result : PASS (Reference : ETC's Report NO.14-04-NEF-001)

## Testing Item: IP56M

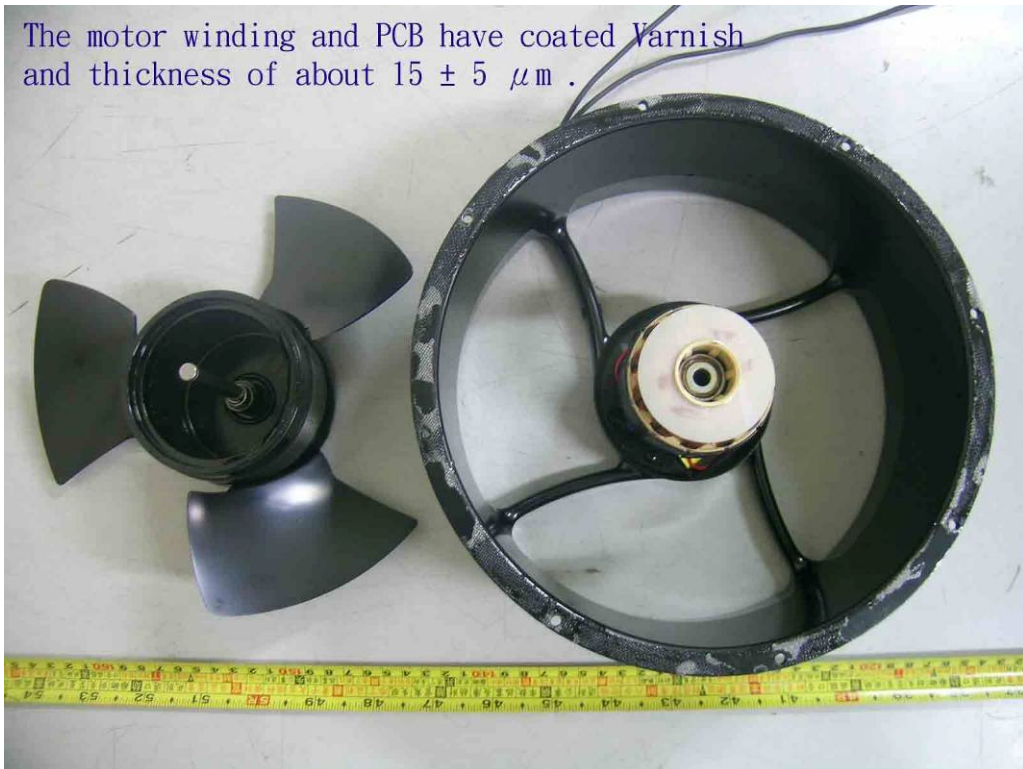
## Axial fans (FDA2-25489) : Inside

The motor winding and PCB have coated Varnish and thickness of about  $15 \pm 5 \mu\text{m}$ .

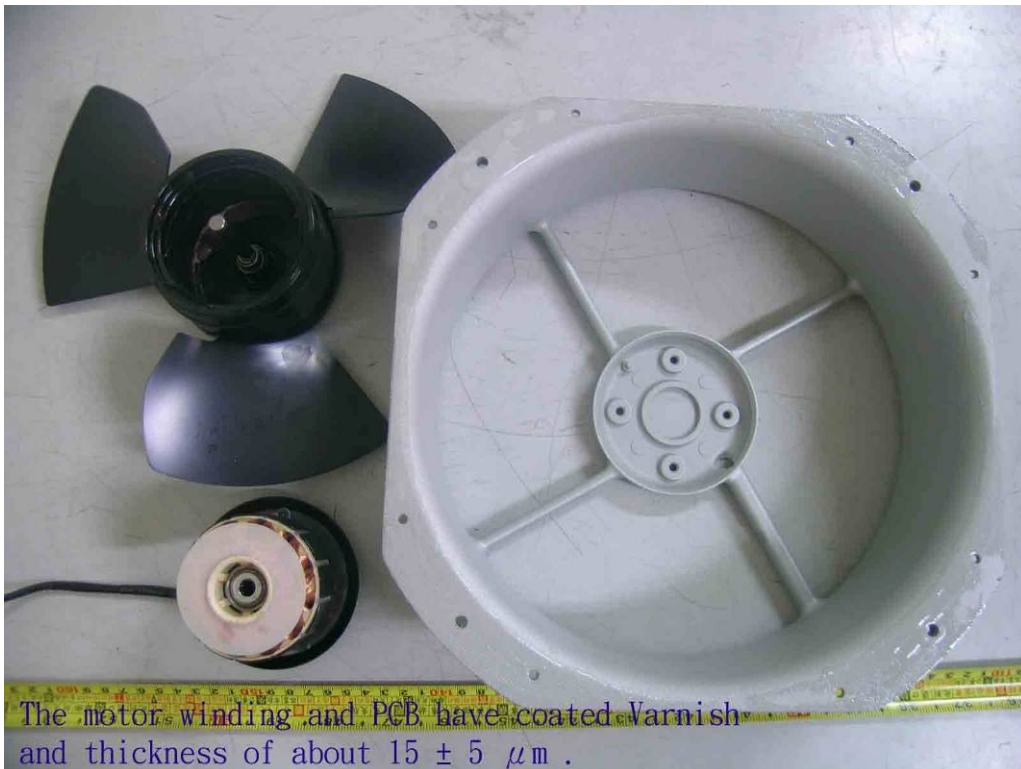
## Axial fans (FDA2-28080) : Inside

The motor winding and PCB have coated Varnish and thickness of about  $15 \pm 5 \mu\text{m}$  .

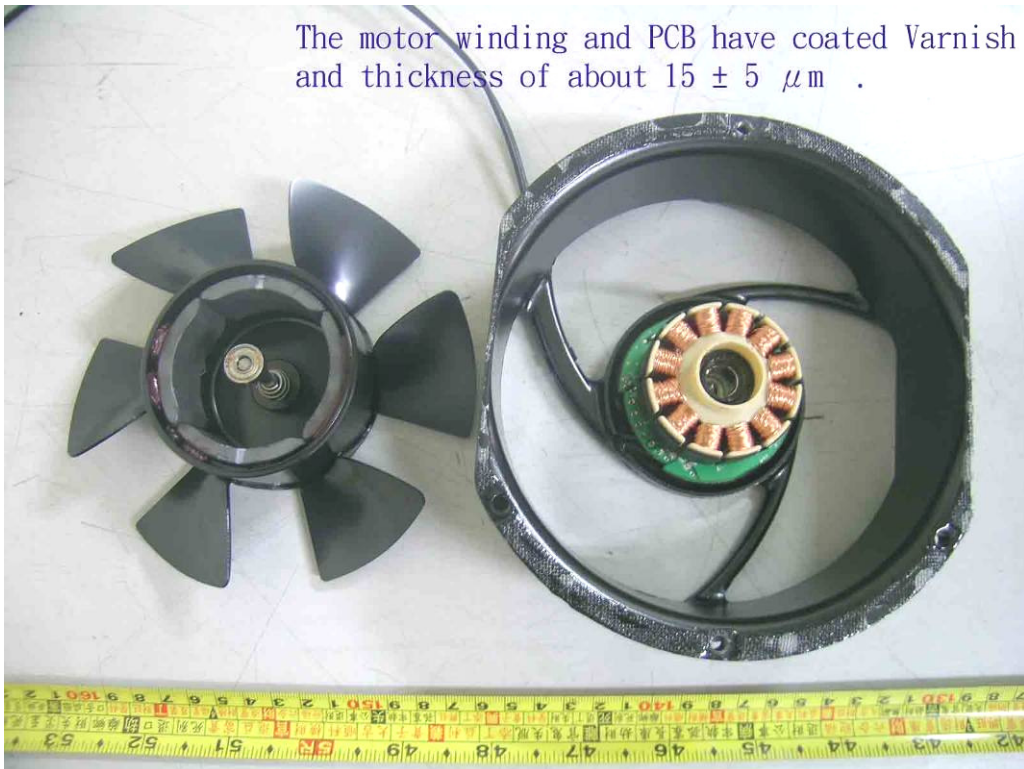
**Axial fans (FDD1-17251) : Inside**

The motor winding and PCB have coated Varnish  
and thickness of about  $15 \pm 5 \mu\text{m}$  .
